**Flood Control Project Maintenance
Levee Inspections**

Maintenance Issue Types Only, Levee Inspection Report By Mile - Fall 2016

Reclamation District No. 2062 Stewart

Waterway	Bank	Unit Miles	Inspection Start/End	Inspector
Unit No. 01 San Joaquin River	Left	2.64	09/28/2016 09/28/2016	Maksim Khashchuk

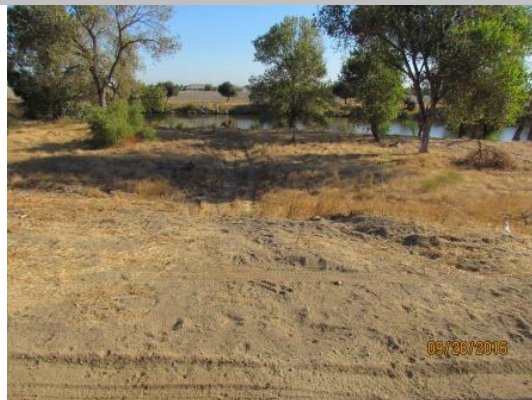
Photo 1 of 1 : FA_2016_RD2062_309_9_20160929_00012.jpg

LM Start	2.14	Rating **	M	Issue No.	9
LM End	2.14	Issue Type +	Ma	Location *	WS
Category	Earthen Levee			GPS Latitude/Longitude	
				Start	End
Item	Slope Stability			37.793991 °	37.793991 °
				-121.308524 °	-121.308524 °
DWR ID	DWR_RD2062_01_f_2016_9				
Comment Code					
S3 : Repair the levee slope damaged by vehicle traffic and prevent access where possible.					
Inspector Comment					
It is recommended to control levee access to prevent possible future damage to the levee slopes.

View of the waterside levee slope erosion due to vehicles driving on the slope.

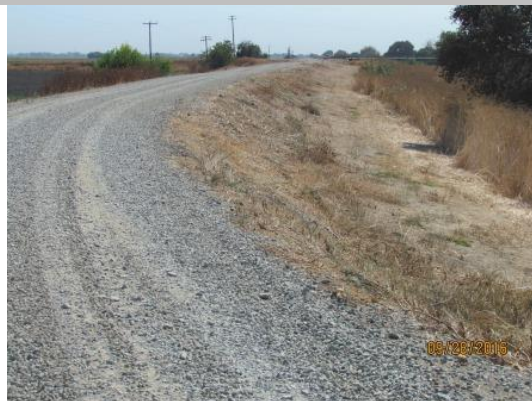
Photo 1 of 1 : FA_2016_RD2062_310_11_20160929_00030.jpg

LM Start	2.76	Rating **	A	Issue No.	11
LM End	2.76	Issue Type +	Ma	Location *	WS
Category	Earthen Levee			GPS Latitude/Longitude	
				Start	End
Item	Vegetation			37.803462°	37.803462°
				-121.371146°	-121.371146°
DWR ID	DWR_RD2062_02_f_2016_11				
Comment Code					
V1 : Control annual grass and weeds on the levee slopes and easements.					
Inspector Comment					
LMA has good vegetation control program.

View of the vegetation on the waterside levee slope.

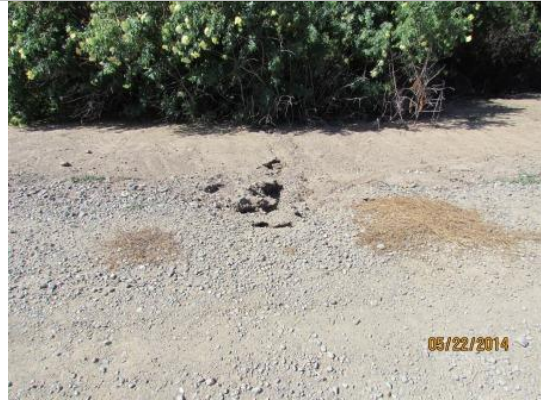
Photo 1 of 1 : FA_2016_RD2062_310_8_20160914_00002.jpg

LM Start	3.64	Rating **	M	Issue No.	8
LM End	3.64	Issue Type +	Ma	Location *	WS
Category	Earthen Levee			GPS Latitude/Longitude	
				Start	End
Item	Erosion / Bank Caving			37.806347°	37.806347°
				-121.386692°	-121.386692°
DWR ID	DWR_RD2062_02_s_2014_8				
Comment Code					
E2 : Schedule repair of erosion site prior to the next inspection.					
Inspector Comment

View of the erosion from surface runoff on the waterside levee slope.

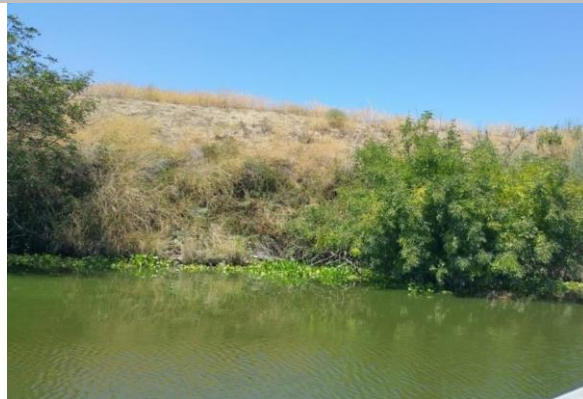
Photo 1 of 2 : SJR2016_RD2062U03RM29.93_1.jpg

07/25/2016: No significant change observed.
 06/25/2015: No significant change observed.
 07/02/2014: No significant change observed.
 08/13/2013: No significant change observed.
 08/07/2012: The site has been visited by boat survey. No significant change observed
 08/23/2011: Site is at the upstream of a drainage ditch. [2016 Site ID:RD2062U03RM29.93]

Front view of the erosion.

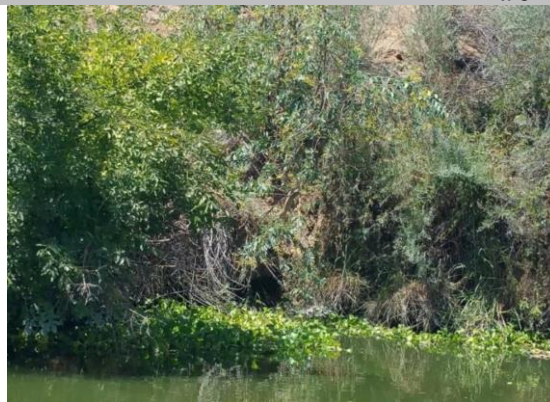
Photo 2 of 2 : SJR2016_RD2062U03RM29.93_2.jpg

Close view of the erosion.

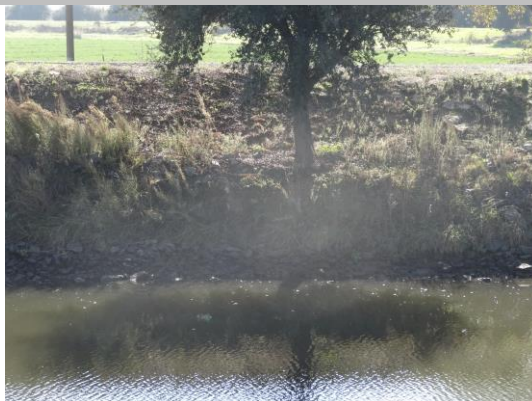
Photo 1 of 2 : SJR2016_RD2062U03RM29.94_1.jpg

LM Start	0.02	Rating **	M	Issue No.	2
LM End	0.03	Issue Type +	Ma	Location *	WS
Category	Supplemental			GPS Latitude/Longitude	
				Start	End
Item	DWR Erosion Survey			37.809514 °	37.809514 °
				-121.390125 °	-121.390125 °
DWR ID					
Comment Code					
Inspector Comment					
11/09/2016: No significant change observed.					
06/25/2015: The erosion is below a large oak tree. Vegetation is visible around the erosion site. [2016 Site ID:RD2062U03RM29.94]

Front view of the erosion site. Note the large tree above the erosion.

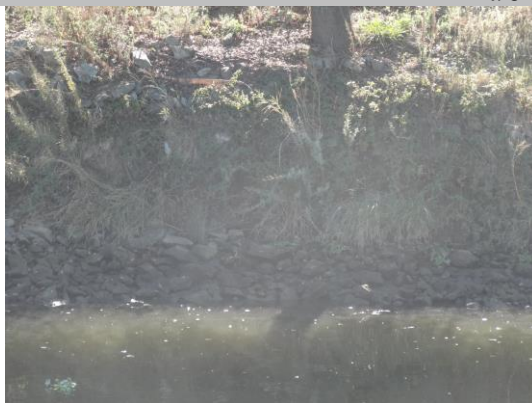
Photo 2 of 2 : SJR2016_RD2062U03RM29.94_3.jpg

Close view of the erosion.

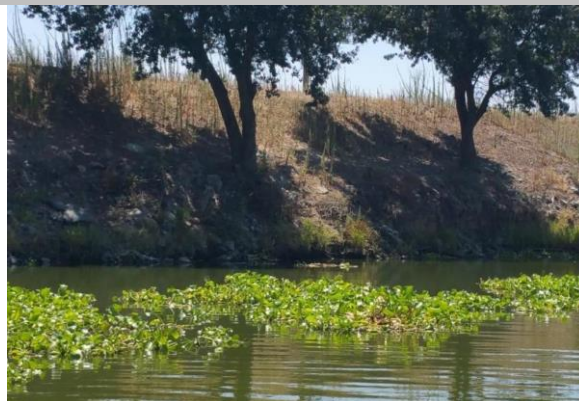
Photo 1 of 2 : SJR2016_RD2062U03RM30.02_1.jpg

07/25/2016: No significant change observed.
 06/25/2015: No significant change observed.
 07/02/2014: No significant change observed.
 08/13/2013: No significant change observed.
 08/07/2012: The site has been visited by boat survey. No significant change observed
 08/23/2011: Hard to view the erosion because of the dense vegetation and trees on site. The site is under the bush, close to the tree. [2016 Site ID:RD2062U03RM30.02]

Front view of the site.

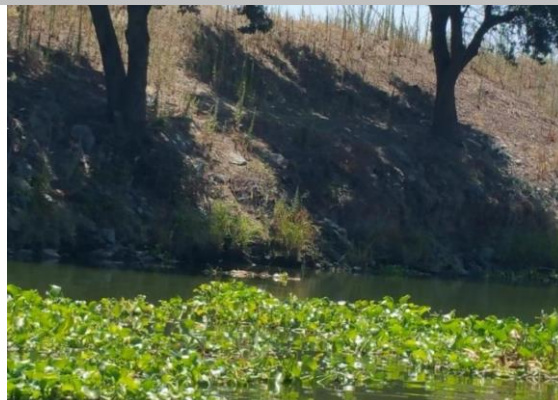
Photo 2 of 2 : SJR2016_RD2062U03RM30.02_2.jpg

Close view of the site. Note vegetation at the site.

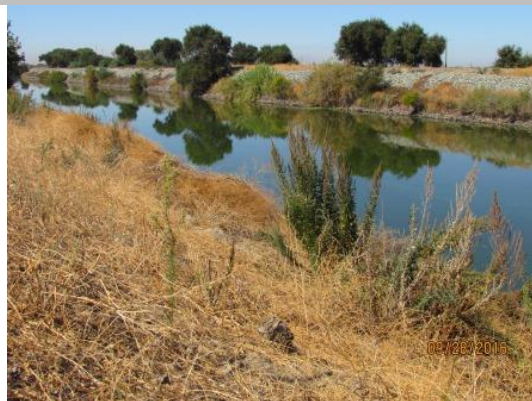
Photo 1 of 1 : FA_2016_RD2062_311_6_20160929_00059.jpg

LM Start	0.17	Rating **	N	Issue No.	6
LM End	0.17	Issue Type +	Ma	Location *	WS
Category	Earthen Levee			GPS Latitude/Longitude	
				Start	End
Item	Trim / Thin Trees			37.810194°	37.810194°
				-121.387602°	-121.387602°
DWR ID	DWR_RD2062_03_s_2012_6				
Comment Code					
T5 : Tree stumps.					
Inspector Comment

View of the tree stump on the waterside levee slope.

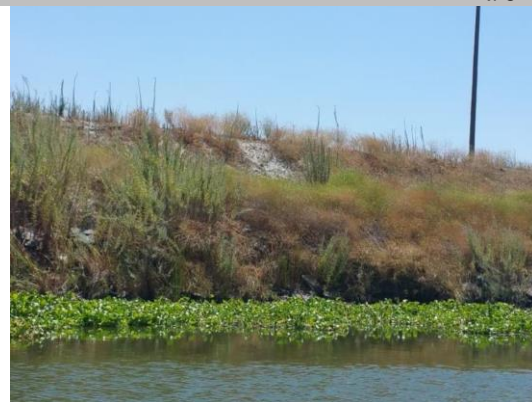
Photo 1 of 2 : SJR2016_RD2062U03RM30.1_1.jpg

LM Start	0.17	Rating **	M	Issue No.	5	
LM End	0.17	Issue Type +	Ma	Location *	WS	
Category	Supplemental			GPS Latitude/Longitude		
				Start	End	
Item	DWR Erosion Survey			37.810268°	37.810268°	
				-121.387495°	-121.387495°	
DWR ID						
Comment Code						
Inspector Comment						
07/25/2016: No significant change observed.						
06/25/2015: No significant change observed.						
07/02/2014: No significant change observed.						
08/13/2013: No significant change observed.						
08/07/2012: The site has been visited by boat survey. No significant change observed						
08/23/2011: The protection at the levee toe has been washed away.						
[2016 Site ID:RD2062U03RM30.1]

Direct view of the site.

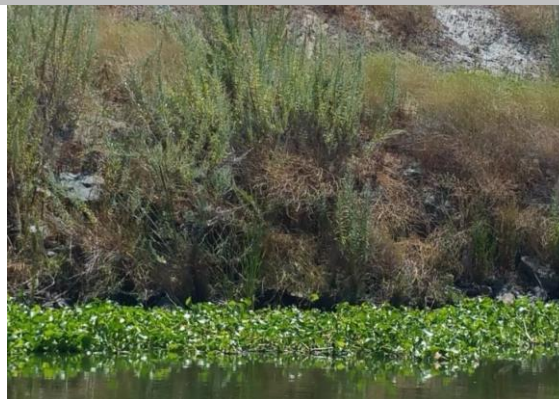
Photo 2 of 2 : SJR2016_RD2062U03RM30.1_2.jpg

07/25/2016: No significant change observed.
 06/25/2015: No significant change observed.
 07/02/2014: No significant change observed.
 08/13/2013: No significant change observed.
 08/07/2012: The site has been visited by boat survey. No significant change observed
 08/23/2011: The protection at the levee toe has been washed away.
 [2016 Site ID:RD2062U03RM30.1]

Close view of the erosion.

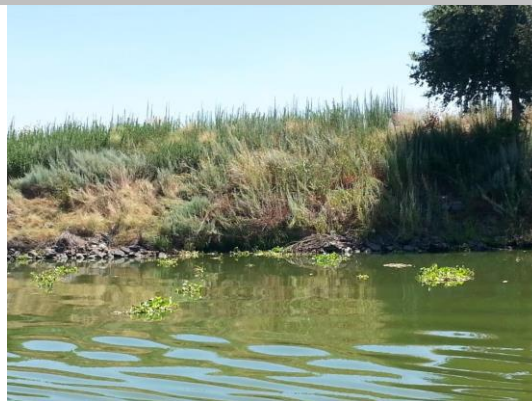
Photo 1 of 1 : SJR2016_RD2062U03RM30.19_2.jpg

07/25/2106: No significant change observed. More vegetation observed at the site.
 06/25/2015: No significant change observed.
 07/02/2014: No significant change observed.
 08/13/2013: A new pocket erosion at the upper levee slope has been found directly above a large tree. The erosion might have been caused by internal pipe leakage or surface runoff.
 08/07/2012: The site has been visited by boat survey. No significant change observed
 08/23/2011: No significant change observed on site. Dense vegetation is visible along the water line.
 09/07/2010: No significant change observed on site. Much of the upper slope was recently cleared of vegetation by spraying. 4- to 6-foot vertical scarp and pocket erosions are lined along a span of 475 feet. In some sections, the vertical scarp encroaches into the levee prism. There is a lack of berm along this reach, exposing the levee slope to high flow velocities during normal and flood events.

08/06/2010: Recommended as local maintenance issue, per CLRO.
 03/09/2010: As discussed with Michael Moncrief of MBK Engineers, the site will be 'addressed' later this year.
 09/29/2009: No major change observed since last visit; pocket erosion and a vertical scarp forming; this site was combined with Site RM30.13 and 30.02 with a combined total erosion length of 475 feet; recommended as annual assessment and monitoring of the site, per CLRO CES Evaluation 2008 Report; previously rated "M".
 11/05/2008: Top of vertical scarp has rip rap that appears to be sliding; rodent holes; existing toe rip rap. [2016 Site ID:RD2062U03RM30.19]

Close view of the pocket erosion. Note the dense vegetation at the site.

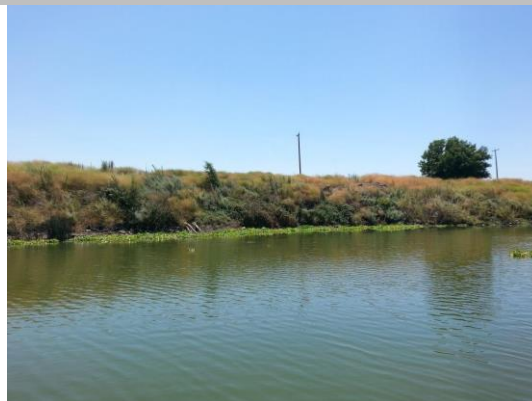
Photo 1 of 3 : SJR2016_RD2062U03RM30.27_1.jpg

07/25/2016: No significant change observed.
 06/25/2015: No significant change observed.
 07/02/2014: No significant change observed.
 08/13/2013: No significant change observed.
 08/07/2012: The site has been visited by boat survey. No significant change observed
 08/23/2011: The site is right at the downstream of a river bend. [2016 Site ID:RD2062U03RM30.27]

Front view of the erosion.

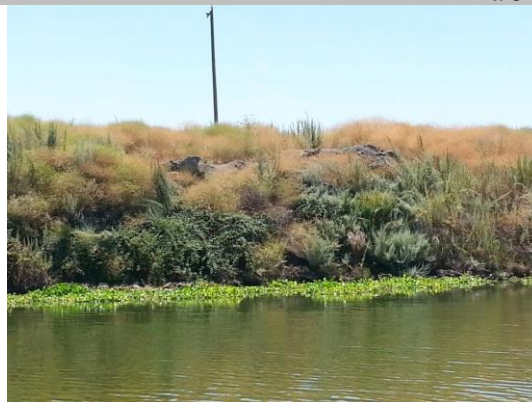
Photo 2 of 3 : SJR2016_RD2062U03RM30.27_2.jpg

Close view of the site. Note the dense vegetation at the site.

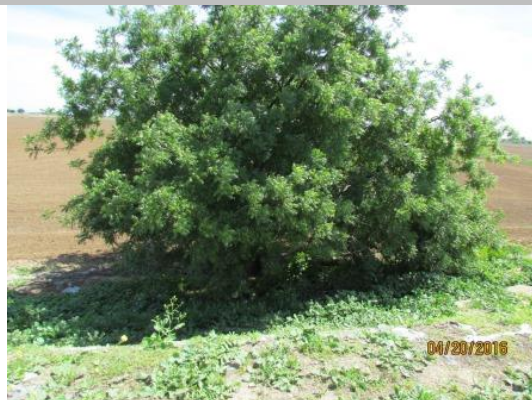
Photo 1 of 1 : FA_2016_RD2062_311_36_20160914_00038.jpg

LM Start	1.04	Rating **	M	Issue No.	36
LM End	1.04	Issue Type +	Ma	Location *	LS
Category	Earthen Levee			GPS Latitude/Longitude	
				Start	End
Item	Trim / Thin Trees			37.817764 °	37.817764 °
				-121.378623 °	-121.378623 °
DWR ID	DWR_RD2062_03_s_2016_36				
Comment Code					
T1 : Trim trees to at least five feet above ground level.					
Inspector Comment

View of the tree at the landside levee toe.

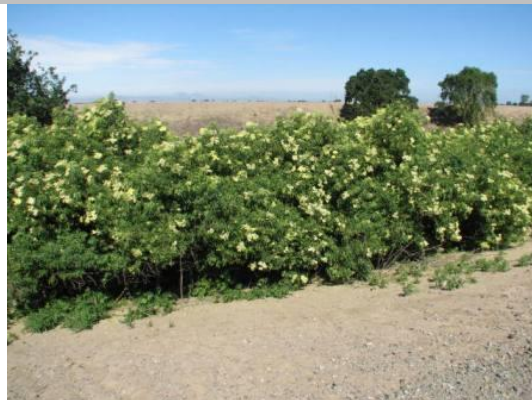
Photo 1 of 1 : FA_2016_RD2062_311_18_20160914_00029.jpg

LM Start	1.35	Rating **	A/W	Issue No.	18
LM End	1.35	Issue Type +	Ma	Location *	WS
Category	Earthen Levee			GPS Latitude/Longitude	
				Start	End
Item	Vegetation			37.820885 °	37.820885 °
				-121.376986 °	-121.376986 °
DWR ID	DWR_RD2062_03_s_2012_18				
Comment Code					
V4 : Elderberries are blocking visibility and flood fight capability.					
Inspector Comment					
Elderberry bush blocks visibility.

05/11/2011 Elderberry bush on water side slope.

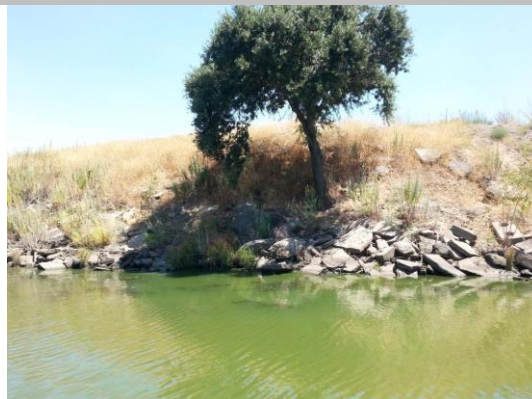
Photo 1 of 2 : SJR2016_RD2062U03RM31.28_1.jpg

07/25/2016: No significant change observed.
 06/25/2015: No significant change observed.
 07/02/2014: No significant change observed.
 08/13/2013: No significant change observed.
 08/07/2012: The site has been visited by boat survey. No significant change observed
 08/23/2011: No significant change observed on site.
 09/07/2010: No significant change observed on site. There is a small- to medium sized Oak tree on the mid-slope just above rip rap. Some of the rip rap has collapsed, creating a pocket erosion just above the existing toe rip rap and upstream of the Oak tree.
 08/06/2010: Recommended as local maintenance issue, per CLRO.
 03/09/2010: As discussed with Michael Moncrief of MBK Engineer, site will be 'addressed' in 2010.
 09/29/2009: No major change since last visit; sliding of the rip rap at the base of the lone tree; there is noticeable man-made trail and foot traffic extending from the crown to the toe; much of the broken concrete used as temporary rip rap has slid, exposing portion of the bare levee slope; recommended as local maintenance issue, per CLRO CES Evaluation 2008 Report; Site # is the same as RM31.3, LM1.45; previously rated "M".

Front view of the erosion site.

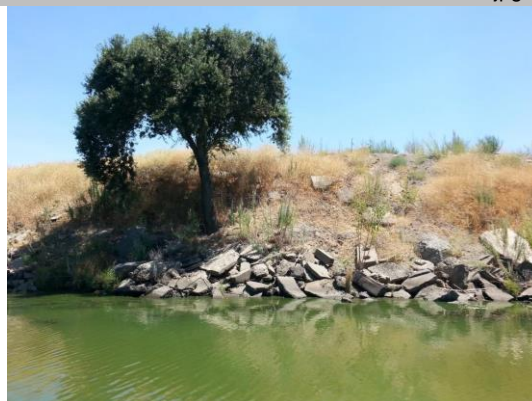
Photo 2 of 2 : SJR2016_RD2062U03RM31.28_3.jpg

Front view of the site. Note the existing broken concrete on the upper levee slope as well as on the lower slope and at the toe.

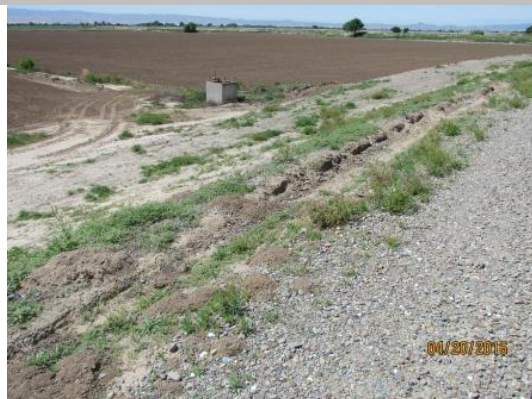
Photo 1 of 1 : FA_2016_RD2062_311_29_20160914_00032.jpg

LM Start	1.61	Rating **	M	Issue No.	29
LM End	1.61	Issue Type +	Ma	Location *	LS
Category	Earthen Levee			GPS Latitude/Longitude	
				Start	End
Item	Crown Surface / Depressions / Rutting			37.820833 °	37.820833 °
				-121.373152 °	-121.373152 °
DWR ID	DWR_RD2062_03_s _ 2016_29				
Comment Code					
C1 : Add appropriate material and re-grade the levee to bring the crown above the design elevation.					
Inspector Comment

View of a tire rut on the landside levee hinge.

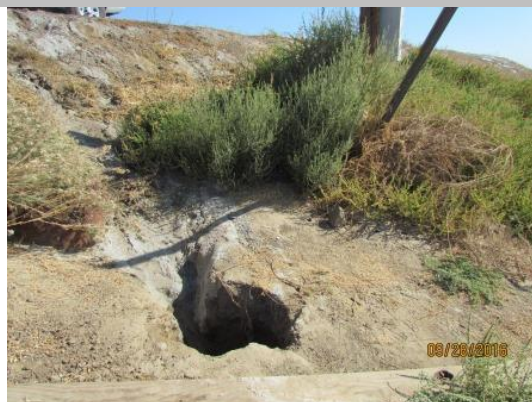
Photo 1 of 1 : FA_2016_RD2062_311_40_20160929_00057.jpg

LM Start	2.12	Rating **	A/W	Issue No.	40
LM End	2.12	Issue Type +	Ma	Location *	LS
Category	Earthen Levee			GPS Latitude/Longitude	
				Start	End
Item	Erosion / Bank Caving			37.818620 °	37.818620 °
				-121.364830 °	-121.364830 °
DWR ID	DWR_RD2062_03_f_2016_40				
Comment Code					
E2 : Schedule repair of erosion site prior to the next inspection.					
Inspector Comment					
LMA corrected the erosion of levee due to break in the pipe.

View of the landside levee slope damaged by pipe.

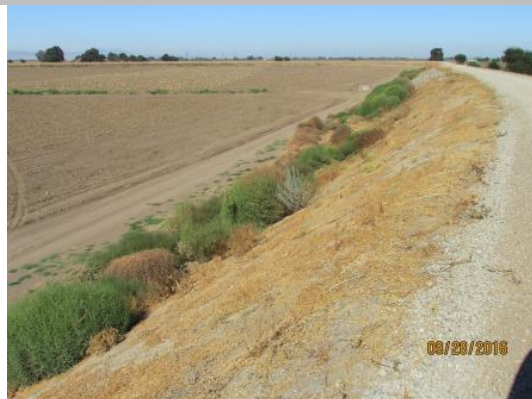
Photo 1 of 1 : FA_2016_RD2062_311_39_20160929_00056.jpg

LM Start	3.40	Rating **	M	Issue No.	39
LM End	3.56	Issue Type +	Ma	Location *	LS
Category	Earthen Levee			GPS Latitude/Longitude	
				Start	End
Item	Vegetation			37.819007 °	37.817526 °
				-121.345610 °	-121.343479 °
DWR ID	DWR_RD2062_03_f_2016_39				
Comment Code					
V1 : Control annual grass and weeds on the levee slopes and easements.					
Inspector Comment

View of the vegetation at the landside levee toe.

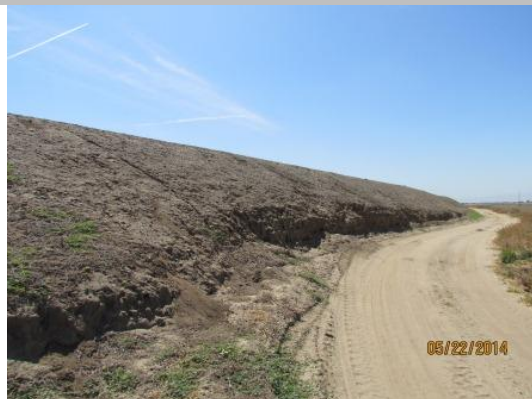
Photo 1 of 1 : FA_2016_RD2062_311_35_20160914_00037.jpg

LM Start	4.83	Rating **	M	Issue No.	35
LM End	4.91	Issue Type +	Ma	Location *	LS
Category	Earthen Levee			GPS Latitude/Longitude	
				Start	End
Item	Erosion / Bank Caving			37.812849 °	37.811682 °
				-121.336116 °	-121.336271 °
DWR ID	DWR_RD2062_03_f_2014_35				
Comment Code					
E1 : Note and monitor erosion site.					
Inspector Comment					
2 to 3 feet vertical cut possibly caused by previous floods.

View of a 2-3 feet vertical cut at the landside levee toe.
